# Effects of Soluble Salts on Coating Life in Atmospheric Services

*The authors describe the results of 14 years of exposure testing in urban, rural, and industrial atmospheres and more than 4 years of testing in marine atmospheres.*

by M. Morcillo and J. Simancas,  
*Centro Nacional de Investigaciones Metalúrgicas, CSIC*

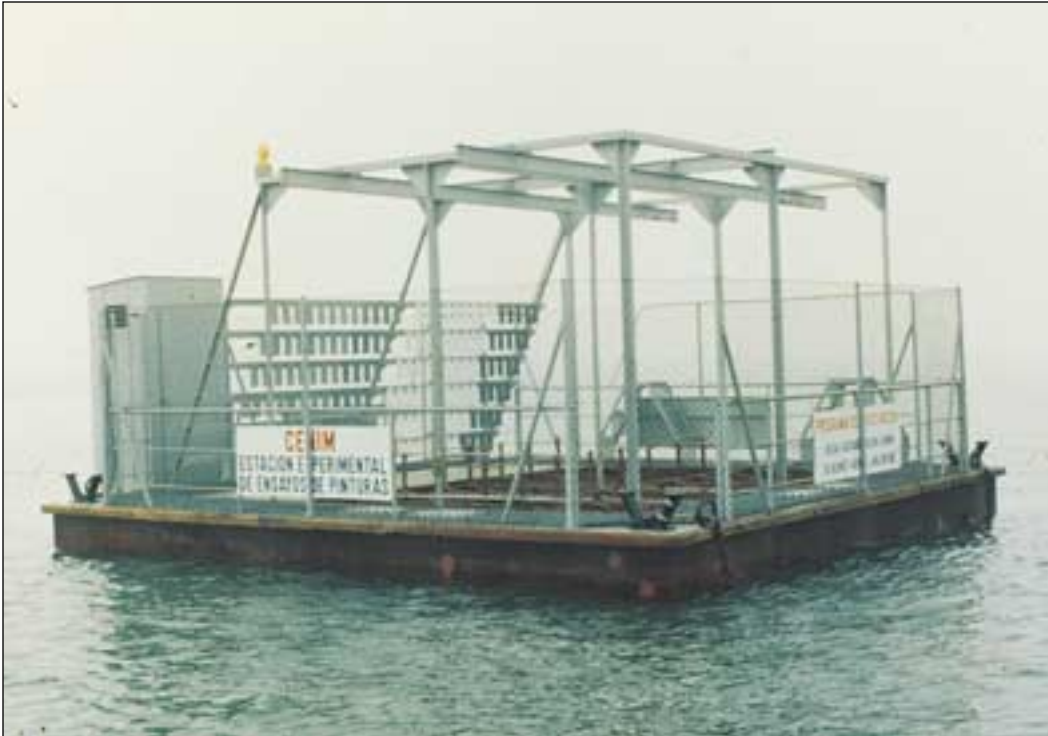
Fig. 1 - Marine environment paint testing raft. The atmospheric exposure test rack can be seen on the deck at center-left.

Although this is a long-standing problem, numerous questions remain. This article attempts to answer some questions about the effect of salt contaminant concentration, atmospheric conditions (rural, urban, and industrial atmospheres), and marine conditions on coating life. Part I of this article describes results of 14 years of research conducted in outdoor atmospheric testing stations on steel contaminated with chlorides or sulfates. Part II of the present article describes 4.5 years of research on salt-contaminated steel in marine atmospheric exposures (Fig. 1).

Figure 1 shows a photograph of one of the marine testing rafts. As can be seen, the raft incorporates a rack for atmospheric testing.

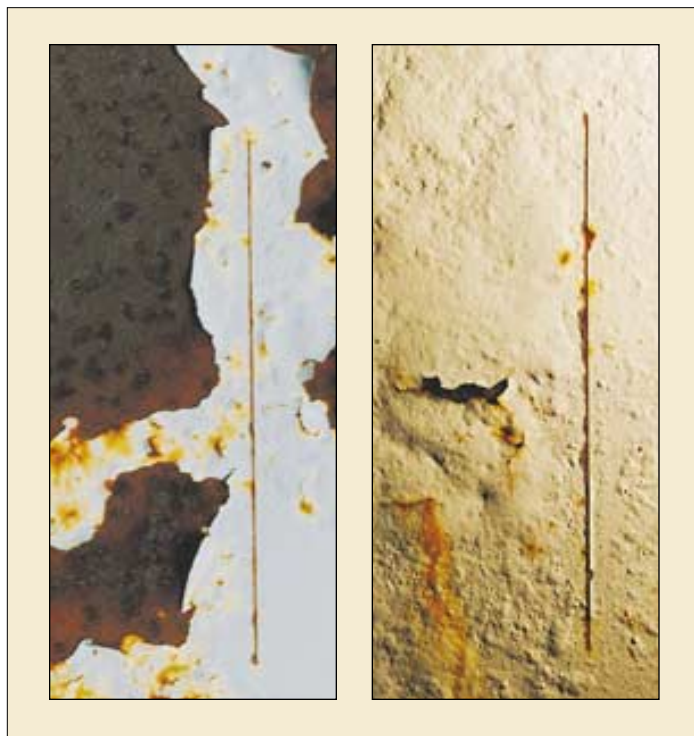
Fig. 2 - The epoxy/polyurethane paint system is sensitive to chloride contamination ( $303.4 \text{ mg/m}^2$ ) at all film thicknesses.

Figs. 2-4 show examples of conditions of the test specimens after 14 years of exposure in the different atmospheres.

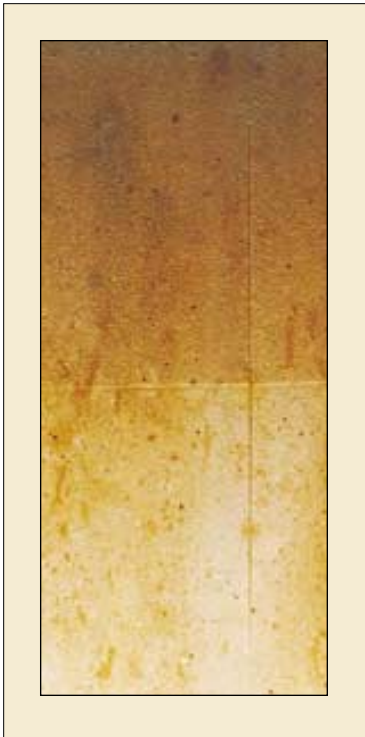
Fig. 3 - (left) The zinc silicate system is not sensitive to chloride contamination. The slight rusting seen in the photograph cannot be attributed to saline interfacial contamination.

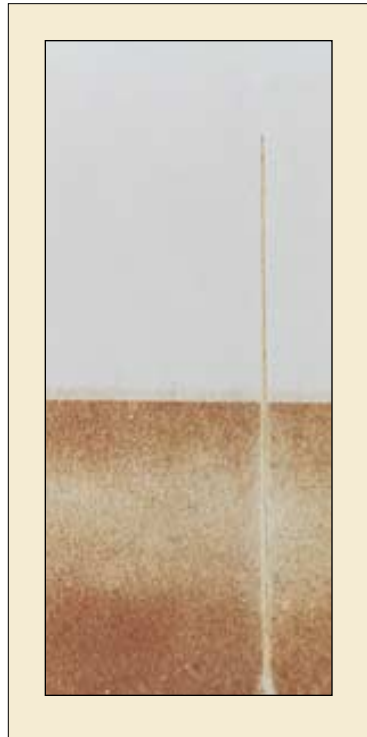
Fig. 4 - (right) The zinc silicate/vinyl system is not sensitive to chloride contamination. The vinyl topcoat shows considerable chalking.
